Quick updates on ADFOSC

17 Dec 2020

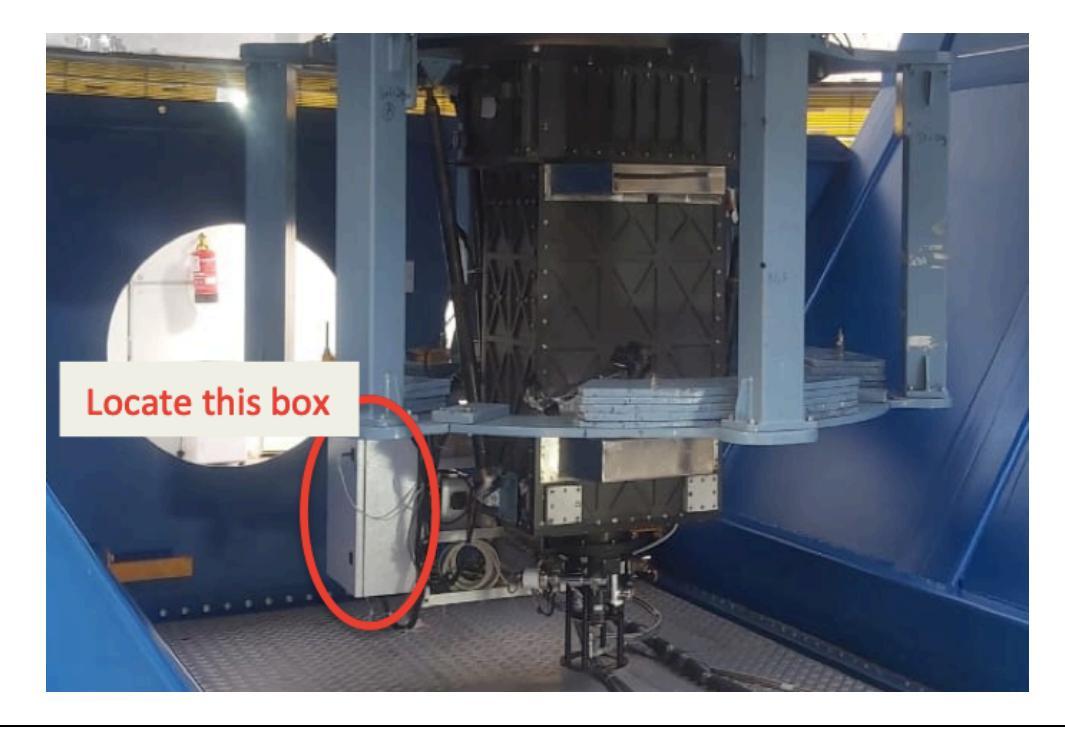
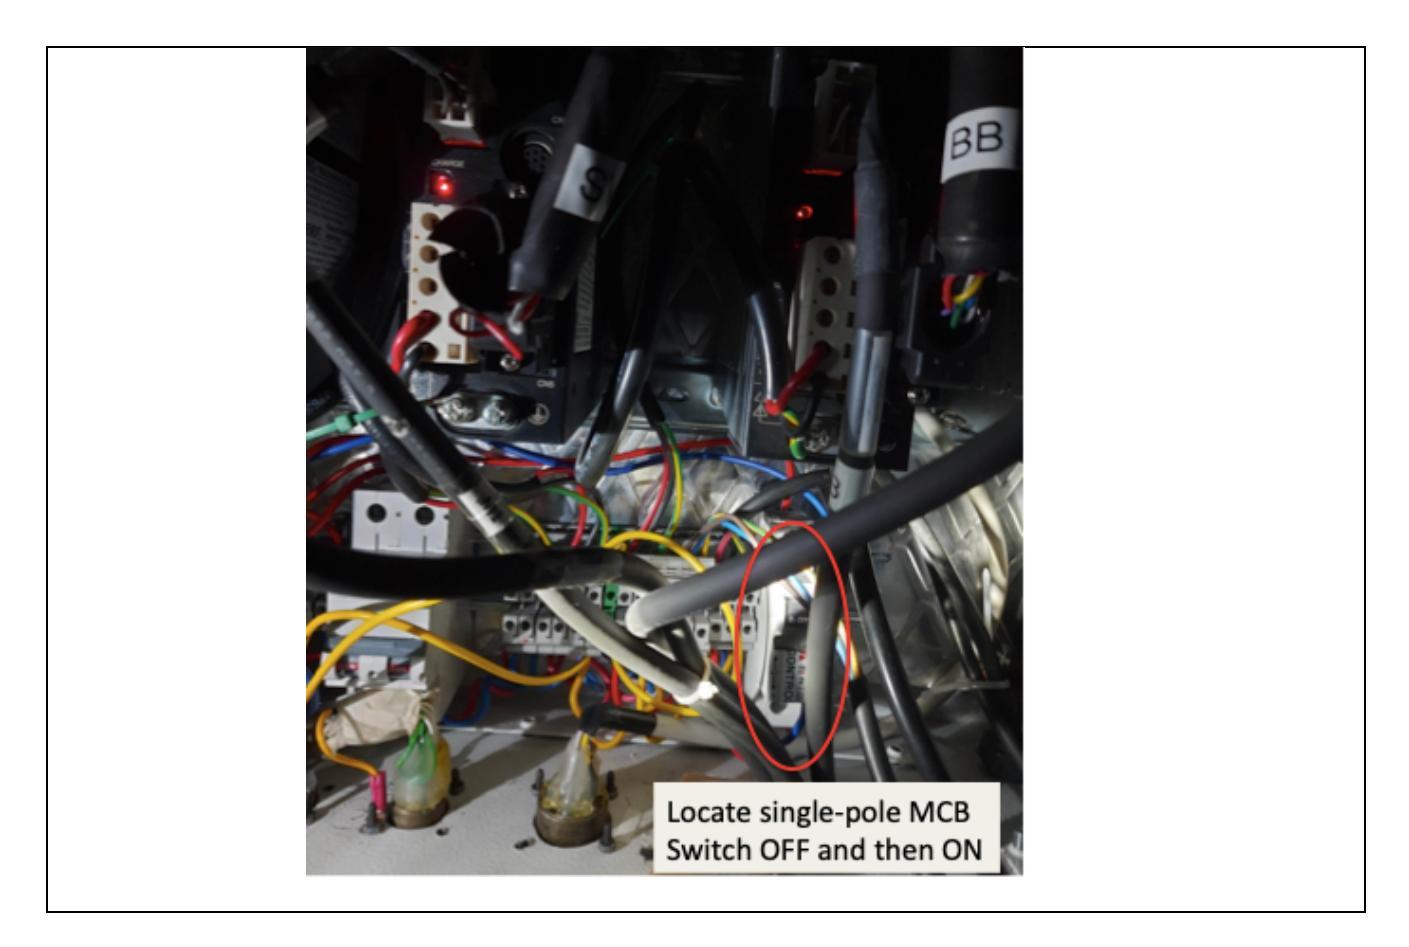
1. ADFOSC wheel control becomes un-responsive

[Occurrence: occasional; Reason: Devasthal Network]:

The system intermittently hangs or gets reset due to some ongoing local network issues at Devasthal. If it happens, the filter movements will not take place as that can be seen from the log (it does not get updated and stops responding) in the ICS control panel. The only solution is to reset the network power of ADFOSC cabinet. The method is given below:

THIS PROCEDURE TO BE PERFORMED BY AN AUTHORIZED PERSON WHO CAN SAFELY HANDLE ELECTRICAL PROCEDURE: Go to telescope floor and locate ADFOSC wheel control box (gray color covered box mounted sideways on dummy weight structure). Use the key provided there to open this box. The single-pole MCB switch as shown below should be switched OFF – wait 10 sec – switch ON.

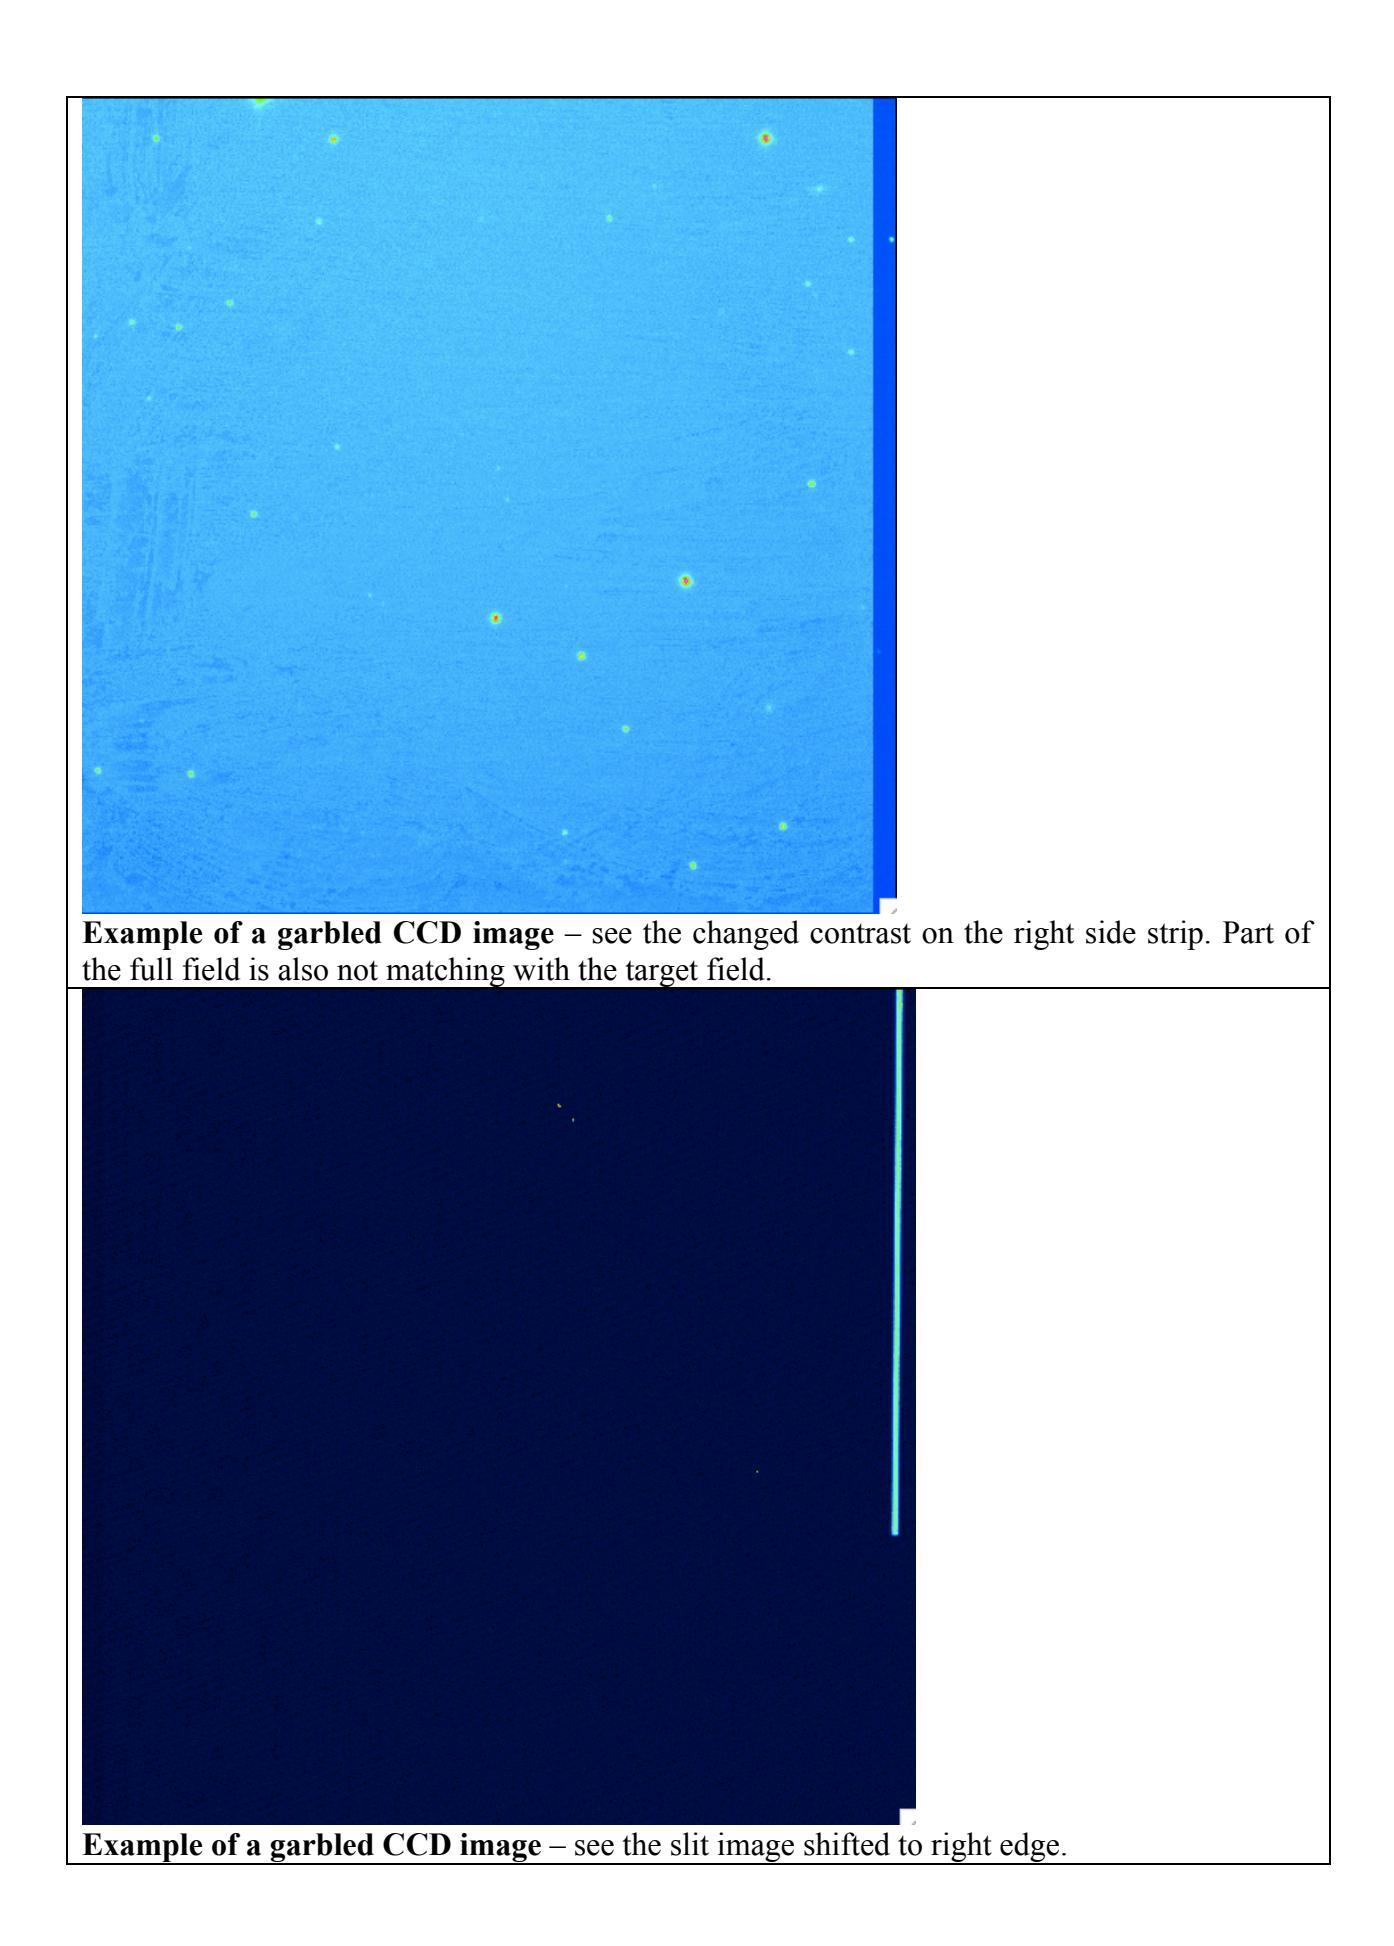
4. Garbled CCD image

[Occurrence: rare; Reason: controller glitch]:

For some reasons, the CCD controller sometimes stiches pixel images with misplaced geometry. This effect is seen as some columns of the center section of image appearing at right edge with different contrast or if a slit is placed, the slit appears at the right edge. If you see images as shown below, reset the CCD software, which solves the problem.

Reset CCD by running CCD controller 'setup' sequence from OWL GUI.
